## Memorandum

**From:** Steve Willis  
**To:** Wayne Miller  
**Date:** June 15, 2016  
**Subject:** Site visit to observe EBR well drilling activities at Former Williams AFB Site ST012.

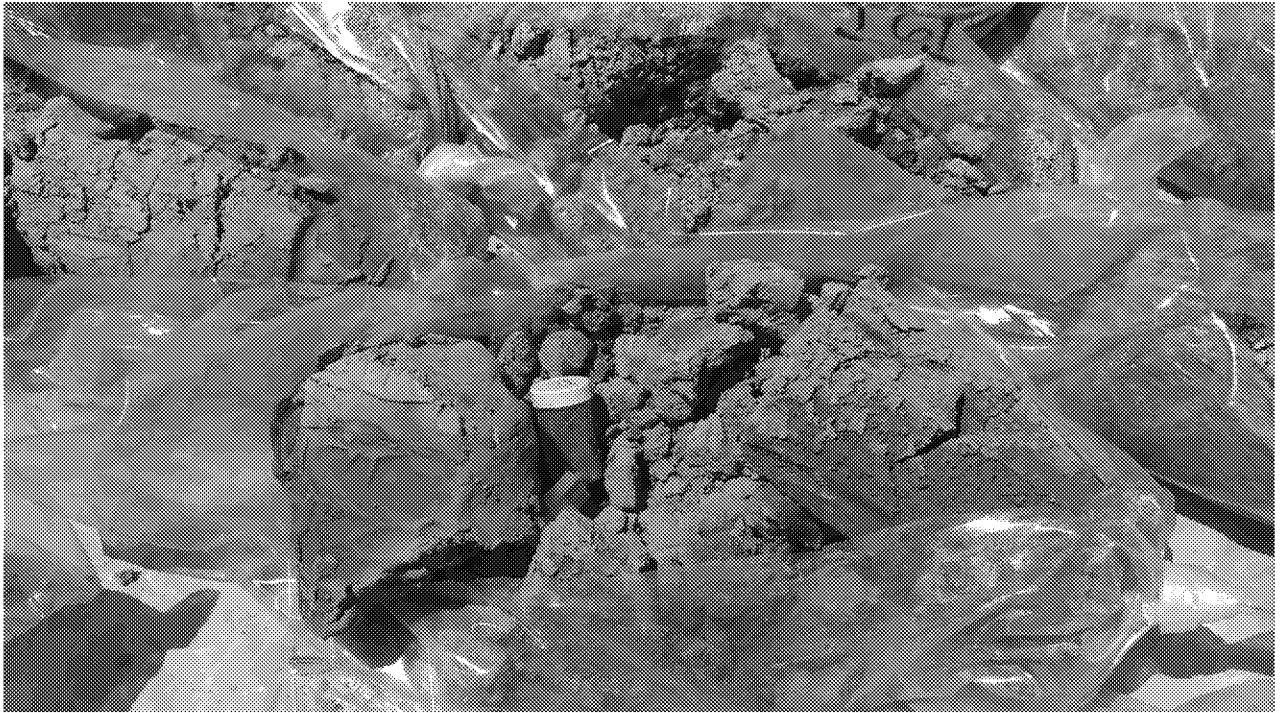
- UWBZ36 screened interval is 170'-190'.
- CZ22/UWBZ35. The boring was drilled to 186'. I checked the remaining cuttings for evidence of contamination and discussed findings with Kyle Keegan. Hydrocarbon odors were first noted at about 170'. A PID reading measured 1,700 ppm and a positive dye test was recorded. I checked the dye test, but could not confirm the positive result because the plastic container was cracked and much of the oil/water mixture had leaked out (see attached photo). Odors and PID readings both decreased below 170'. At 178' the PID reading was 300 ppm and at 186' it was 3 ppm. I confirmed no hydrocarbon odors below 180'. The well was screened in the Cobble Zone at 143'-158' and in the UWBZ at 168'-183'.

Photo 1. CZ22/UWBZ35. Dye test kit in cuttings at 170'. Test kit container was broken, so positive result could not be confirmed.
